# CASE STUDY

How Moody Heat Exchangers Refurbished a WeldPack® Heat Exchanger for an Oil & Gas Production Company

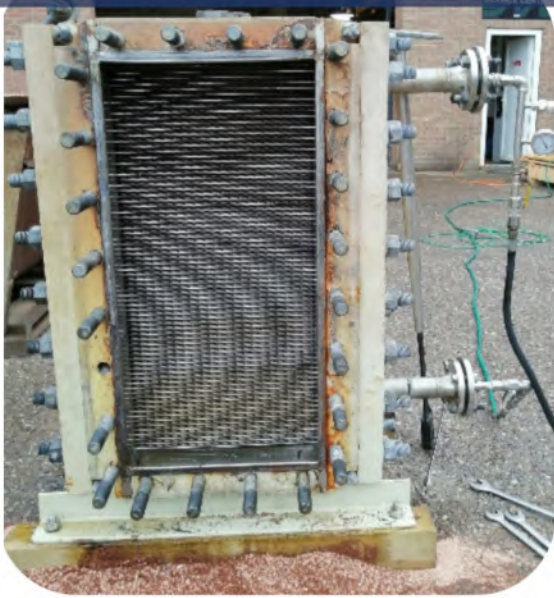
## Integrity Testing

The testing as expected, demonstrated leakages. Further investigation and removal of the side panels from the Lean TEG passage revealed that the graphite sealing material was over compressed and compromised. Further pressure testing with both side panels open allowed the experienced team of engineers to identify the exact locations of the leaks.

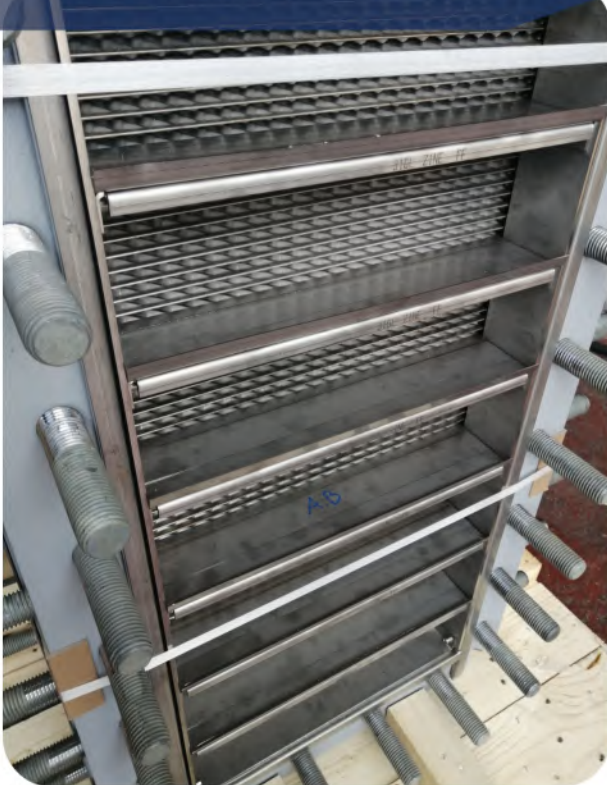
## Refurbished - New Core

A new WeldPack® core was quickly sourced and replaced along with new graphite seals installed onto the core. Each side panel was torqued to the manufacturer's specified tolerance. A pressure test was carried out to 16.5 barg to ensure external integrity. An unbalance 5 barg open to atmosphere (0 barg) test was also performed on the lean TEG passage then reversed and tested on the rich TEG passage.

The newly refurbished WeldPack® welded heat exchanger's performance has been enhanced and no longer fails pressure and integrity testing. From the initial query through to reinstallation of the unit on the offshore site, took under 7 weeks.
