CASE STUDY

Moody Heat Exchangers
Brings Plate Heat
Exchanger (PHE) Back to
Specification for one of the
UK's Largest Power Stations

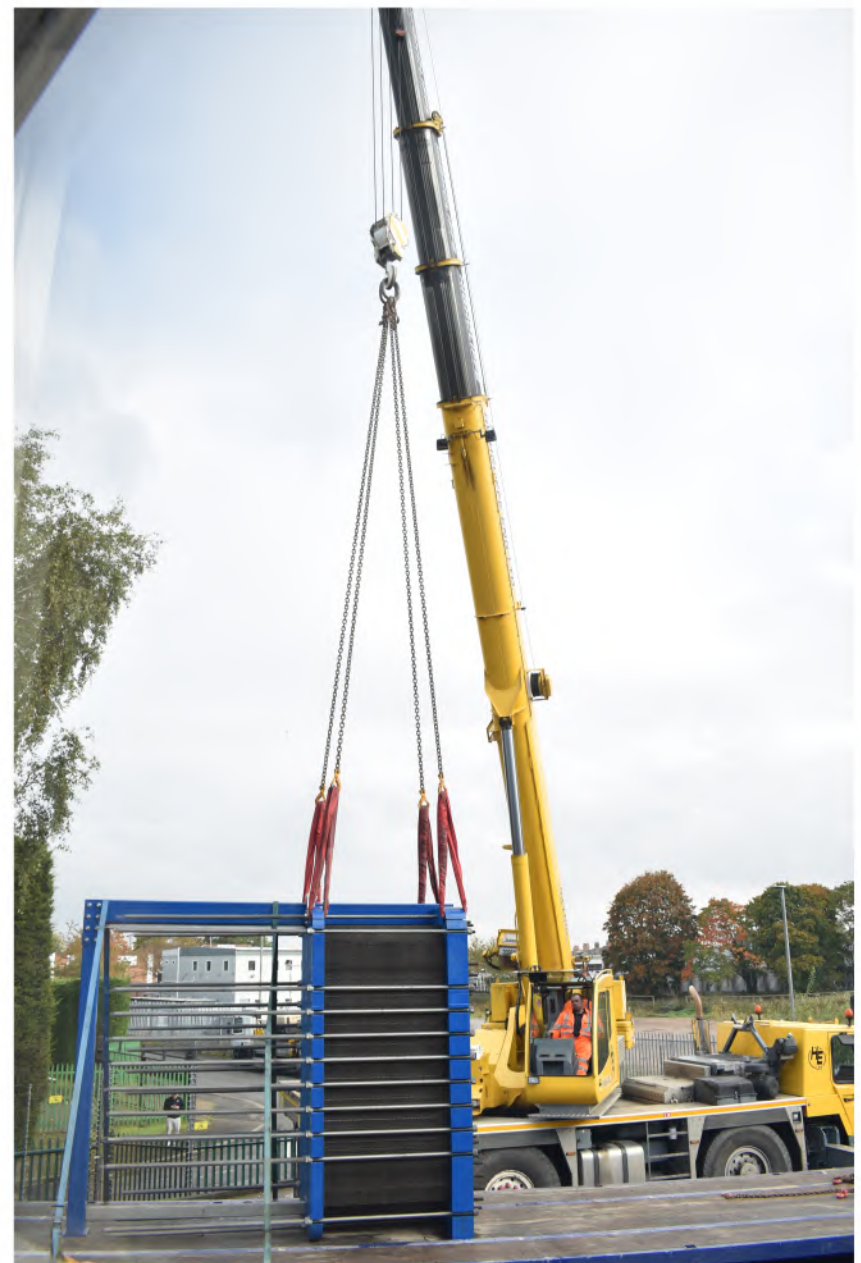
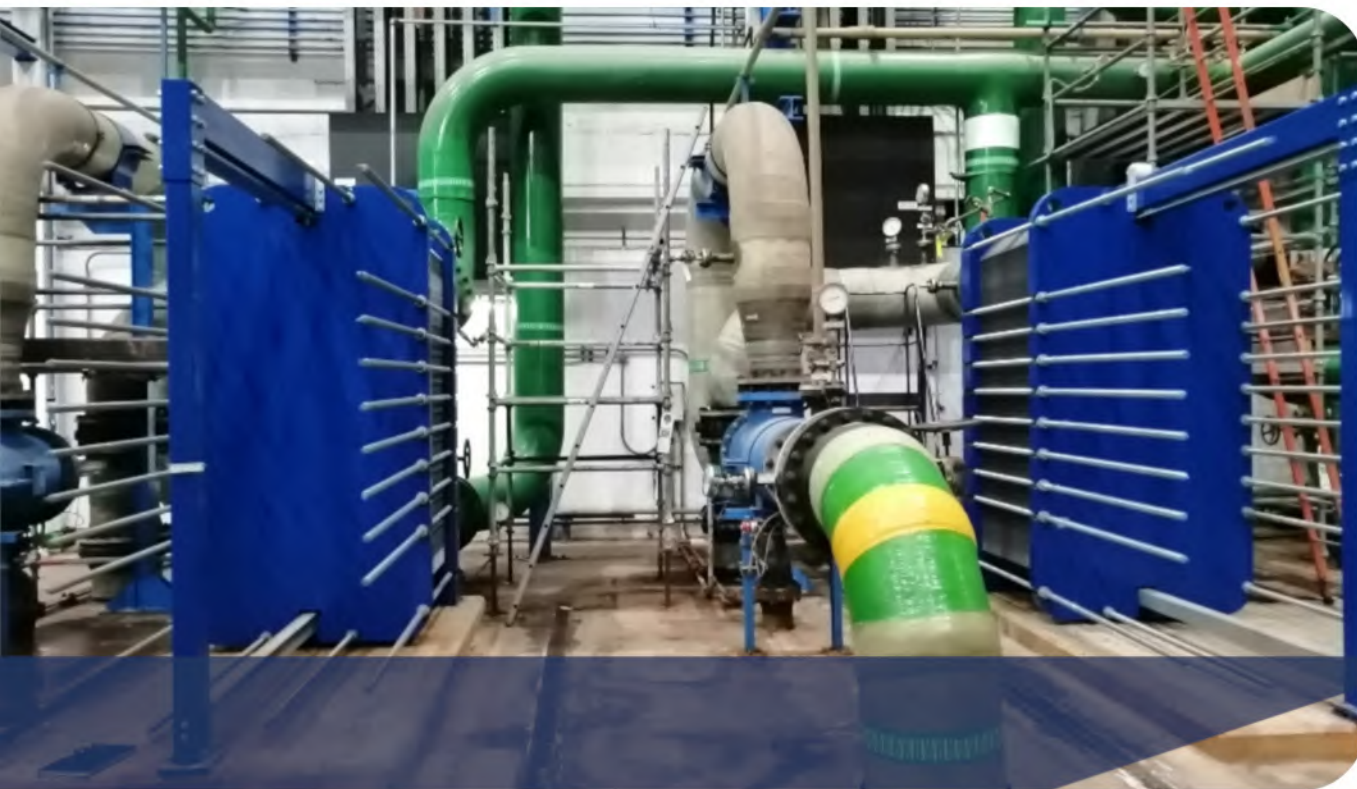
The 12 ton PHE was removed from the site and shipped to Moody Heat Exchangers' state-of-the-art refurbishment facility in Retford, Nottinghamshire, to undergo a complete service overhaul.

Once received at our refurbishment centre the first stage of servicing took place. The PHE was fully dismantled to enable our experienced engineers to facilitate inspections.

Full inspection of the frame and non-destructive testing of the port liners took place and the process of plate refurbishment began.

This included; removing old gaskets from the plates, chemically cleaning the plates to remove scaling and contamination, visual inspection of the cleaned plates, UV crack detection to test plates for the smallest deformities and finally, supplying and fitting new gaskets to the plates that passed final inspection.
